# Inventory of Hazardous Materials (IHM) Report

Job Ref No: **359872**, Account Ref No: **23024**, Contract Ref No: **49355**, IMO:

## HMS BRISTOL

## Inspection Summary

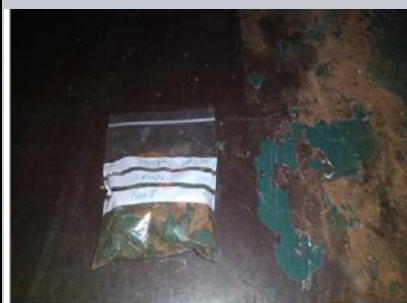
No.	Location Detail	Deck Compartment	Item / Product Examined	Material Description	Hazard	Sample No.	Extent (total)	Initial Control Recommendation	Photograph	
10964	77	-3	045/ Corridor (3L2)	Green coating to deck	Paint	Lead and lead compounds - APP2 - B-3	359872-HAZ-3	0.4 Kg * 400 (160 Kg)	Safe disposal at end of life

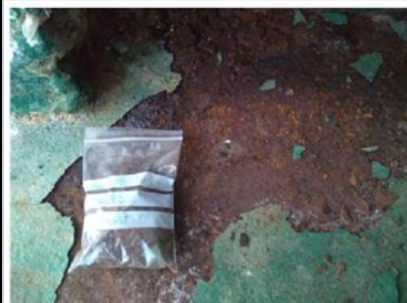
10967	102	-2	002/ Fan Compartment (2QZ2)	Green coating to deck	Paint	Heavy Metals in Paint - B-1 / B-2 / B-3 / B-4	359872-HAZ-5	0.4 Kg * 10 (4 Kg)	Safe disposal at end of life

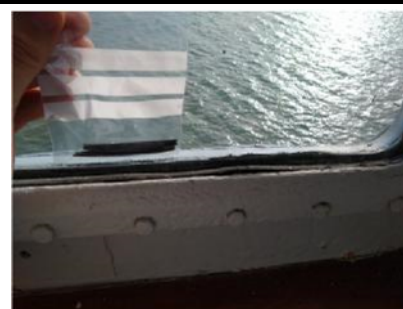
No.	Location Detail	Deck Compartment	Item / Product Examined	Material Description	Hazard	Sample No.	Extent (total)	Initial Control Recommendation	Photograph	
10990	49	03	001/Bridge	Rubber seal to windows	Rubber	Polychlorinated biphenyls - PCB - A-2	359872-HAZ-14	0.1 Kg * 20 (2 Kg)	Safe disposal at end of life
