# Inventory of Hazardous Materials (IHM) Report

Job Ref No: **359872**, Account Ref No: **23024**, Contract Ref No: **49355**, IMO:

## HMS BRISTOL

## Inspection Summary

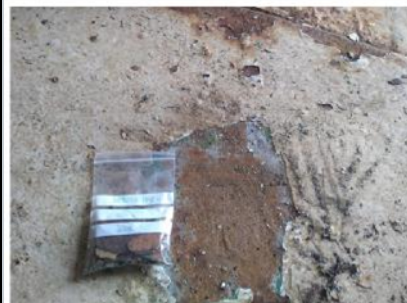
10966	110	-2	001/ Sewage Treatment Plant (ST40)	Grey coating to deck	Paint	Heavy Metals in Paint - B-1 / B-2 / B-3 / B-4	359872-HAZ-4	0.4 Kg * 20 (8 Kg)	Safe disposal at end of life

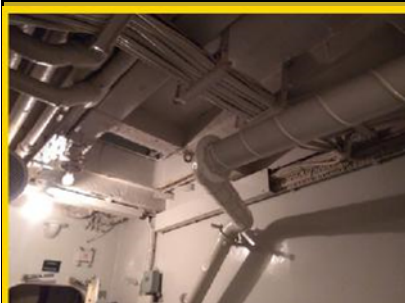
No.	Location Detail	Deck	Compartment	Item / Product Examined	Material Description	Hazard	Sample No.	Extent (total)	Initial Control Recommendation	Photograph
14271725	20	-2	037! Corridor (2C)	Sealant to circular air handling duct work joints	Asbestos-containing putty	Chrysotile	20357891-84	7 No.	Reinspect Periodically

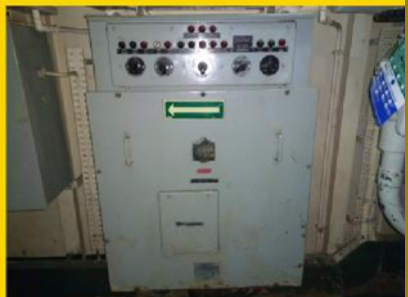
No.	Location Detail	Deck Compartment	Item / Product Examined	Material Description	Hazard	Extent (total)	Initial Control Recommendation	Photograph	
14271776	55	-5	009/ No.3 Aux Machinery Space (5J)	Electrical distribution equipment	Asbestos-containing no access - presumed woven product / putty	Potentially Containing Hazardous Material(s) Chrysotile	10 No.	Reinspect Periodically	<div>

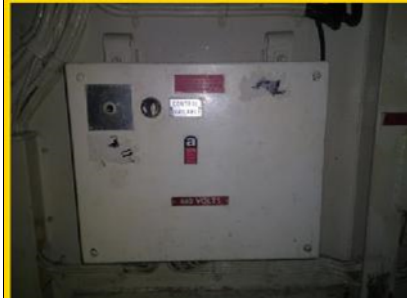
No.	Location Detail	Deck Compartment	Item / Product Examined	Material Description	Hazard	Extent (total)	Initial Control Recommendation	Photograph	
14271695	92	-2	011/ SEDC (2N)	Electrical distribution equipment	Asbestos-containing no access - presumed woven product / putty	Potentially Containing Hazardous Material(s) Chrysotile	1 No.	Reinspect Periodically	<div>R3</div>
14271605	93	-3	027/ Telephone Exchange (3P)	Electrical distribution equipment	Asbestos-containing no access - presumed woven product / putty	Potentially Containing Hazardous Material(s) Chrysotile	2 No. Panels	Reinspect Periodically	<div>

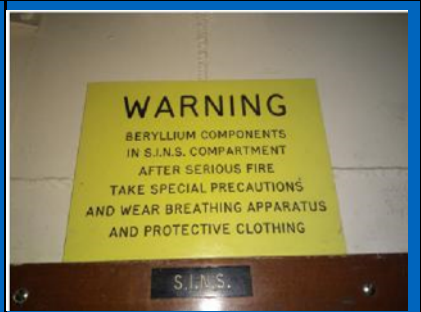
No.	Location Detail	Deck Compartment	Item / Product Examined	Material Description	Hazard	Extent (total)	Initial Control Recommendation	Photograph	
11023	48	-4	030/ S.I.N.S (4H)	SINS Equipment	Internal properies	Radioactive substances - APP2 - B-8	0.01 Kg	Safe disposal at end of life

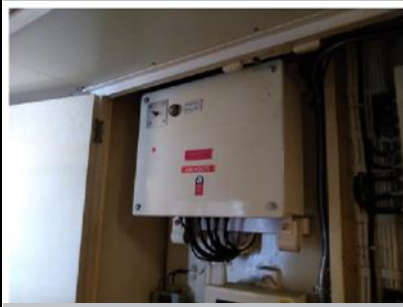
Location Detail	Deck Compartment	Item / Product Examined	Accessibility	Access Comments	Photograph	
50	-1	010/Circulation	Electrical distribution equipment	No Access	Access not authorised

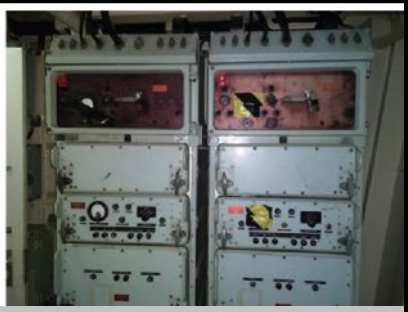
Location Detail	Deck Compartment	Item / Product Examined		Accessibility	Access Comments	Photograph
124	-3	009/ Sonar Instrument Comp (3S)	General access & surveying within electrical equipment	No Access	Live service supply
